# Baltimore SSO

## Site Investigation Report

Project: 10 Gwynns Run System Improvements

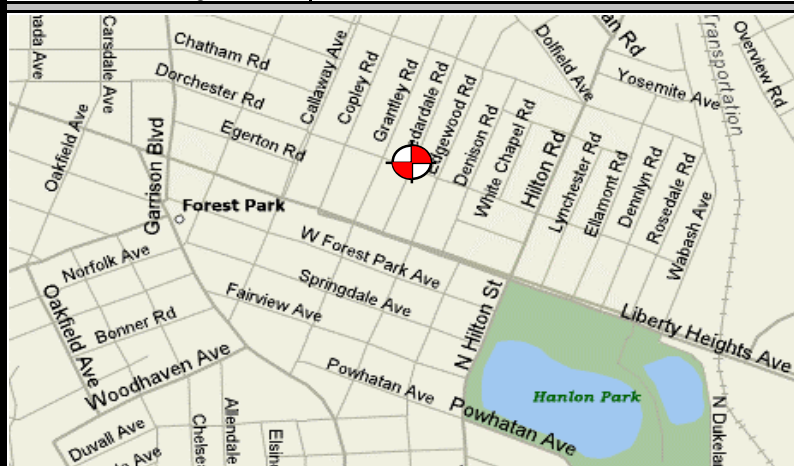
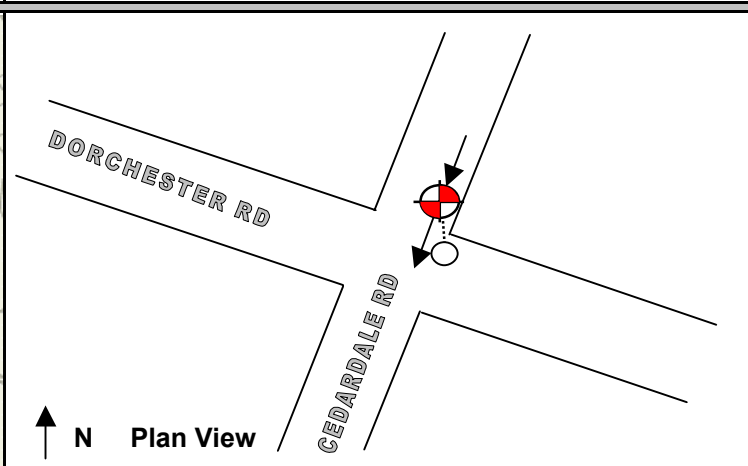
Site Name:	10_103SOF	Monitor Series:	4000 WR	Monitor S/N:		Manhole #:		<b>Investigation Information:</b> Upstream Input: (L/S, P/S) DNI Upstream Manhole: Downstream Manhole: Depth of Flow: 1" + - .5 Description of Site Hydraulics: Turbulent flow in 8-in. sewer. Overflow pipe is dry.
Address / Location:	Dorchester & Cedardale Roads	Map Page #:		Map Grid #:				
		Pipe Height:	12"	Pipe Width:	12"			
Access:	Drive	IP Address:	CDPD					
		GPS Coords:	N DD.dddd 39 19.627		W DD.dddd 076 40.483			
Date/Time of Investigation:	2/16/2005

<b>Manhole Information:</b>
Manhole Depth: 11'
Manhole Material / Condition: Coated / Fair
Active Drop Connections? No

**Notes:** 8-in. Influent pipe is broken with pieces missing. 8-in. effluent pipe is lined. Sensors located in overflow pipe.
