Baltimore SSO

Site Investigation Report

Project Number: 19 Moore's Run

| Site Name: | 19_MR75I | Monitor Series: | 4000 | Monitor S/N: | 1147 | Manhole #: | MR75 | Investigation Information: |

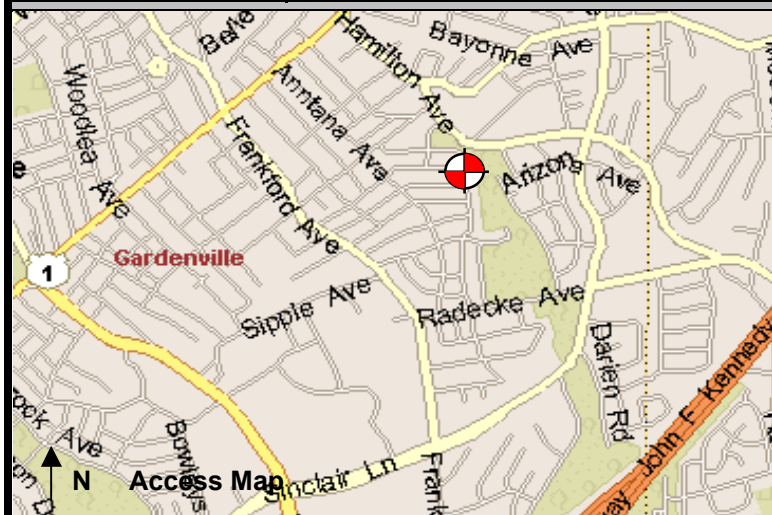
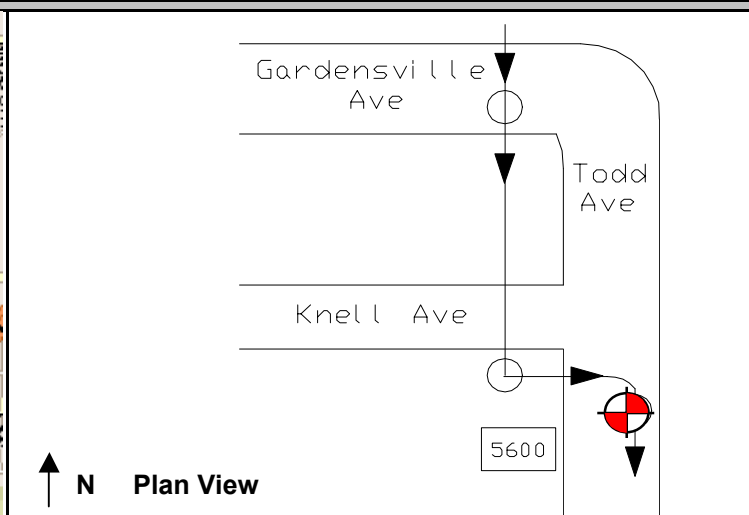
No abnormal flow conditions were observed.

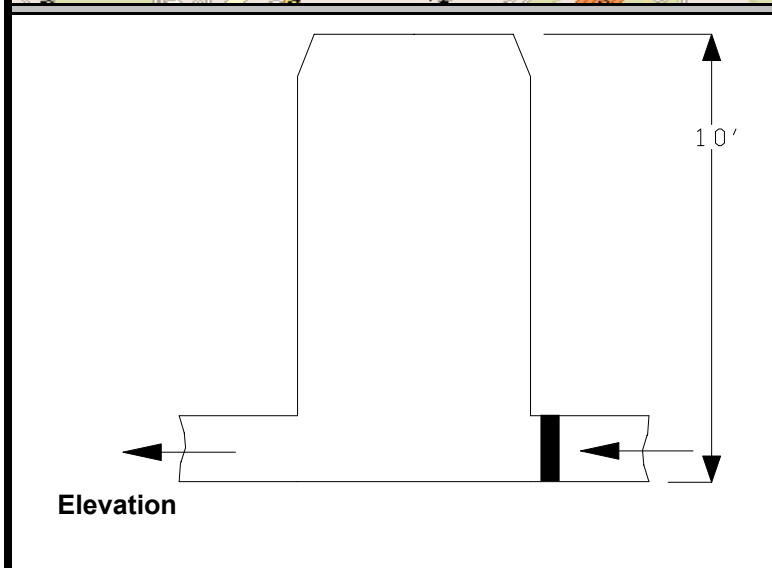
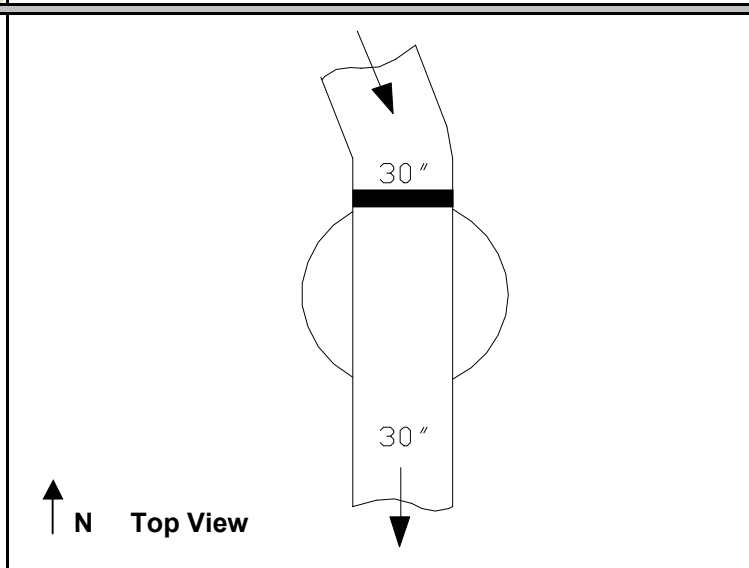
| Manhole Material / Condition: Brick / Fair |

| Odd Shape Pipe |
