Baltimore SSO # 140

Site Investigation Report

Project: High Level Cross Connections

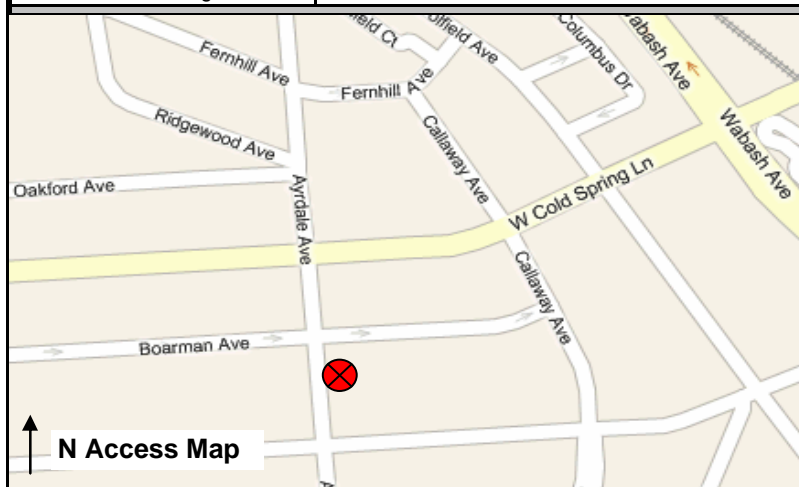
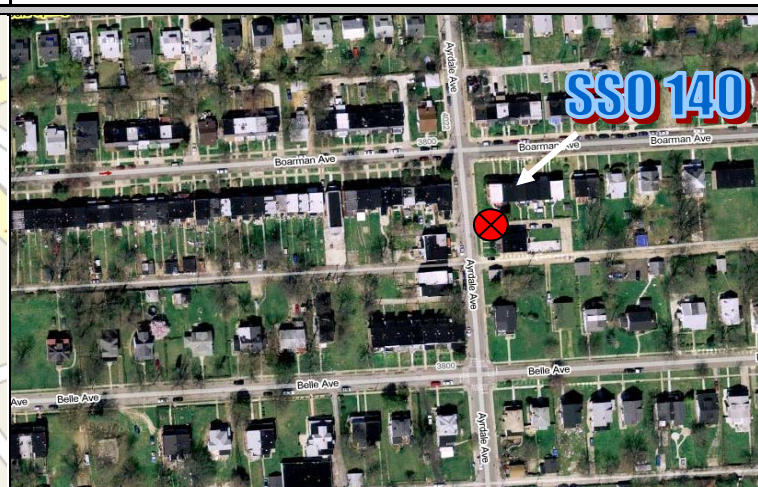
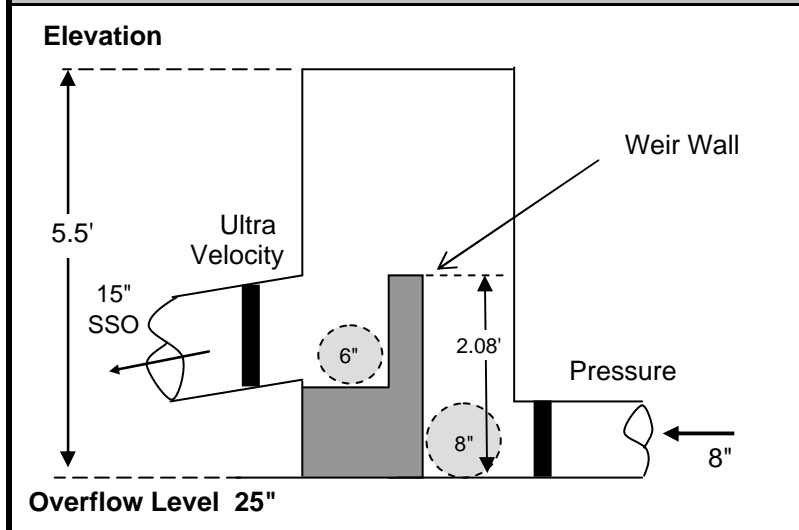
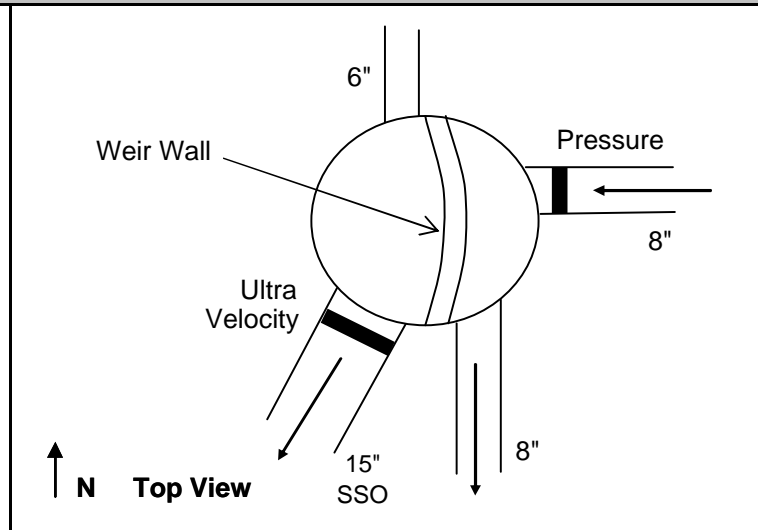
GOOD
Manhole Information:
Manhole Depth: 5.5'
Manhole Material / Condition: Brick / Good
Active Drop Connections? No

System Character:
X Residential
Commercial
Industrial
Notes:
Cast Iron Flap Valve
Sensor Location
N.T.S.- Not to scale

No flow evident in overflow/cross-connection pipe during monitoring period.
