18-4143-00: Hot Springs, AR 2025 SSES

Smoke Observation Summary

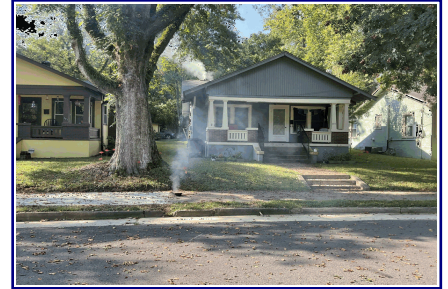
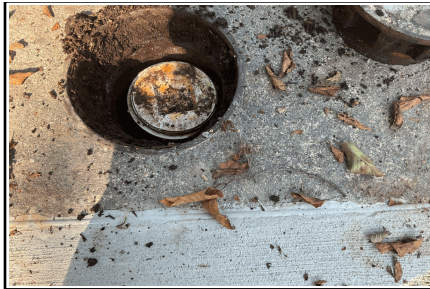
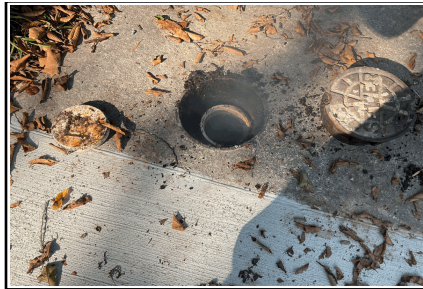
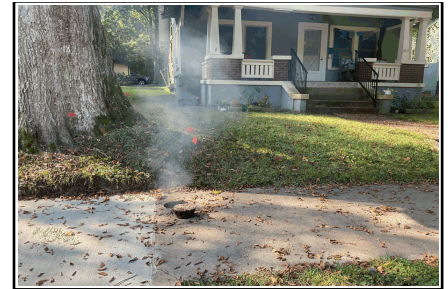
Address: 405 Whittington Ave

Cleanout, Missing/Broken Cap

Basin: **HS15**

Segment (US : DS): **12528:2570**

Intensity: **Medium**

Drainage Area (SF): **25**

Surface: **Paved**

QC Comments: confirm where cleanout defect is - possibly above grade and 0 drainage area - EE

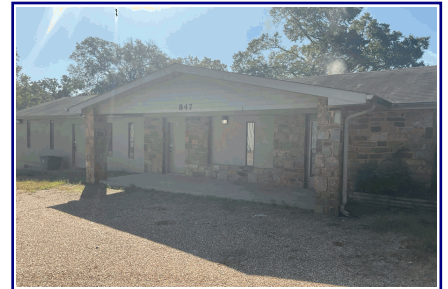
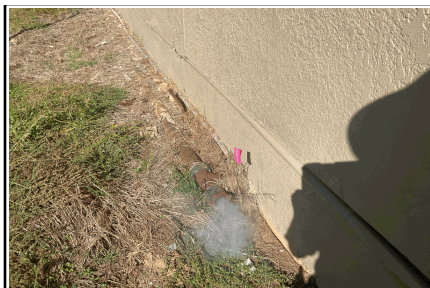
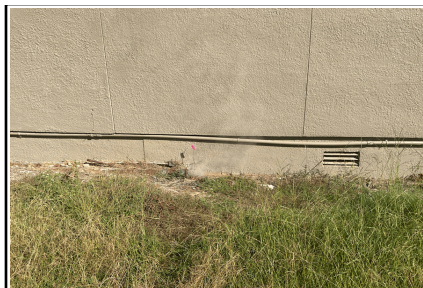
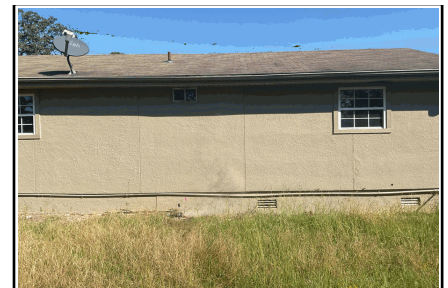
Address: 847 Third St

Cleanout, Missing/Broken Cap

Basin: **HS62**

Segment (US : DS): **2309:2308**

Intensity: **High**

Drainage Area (SF): **10**

Surface: **Unpaved**

QC Comments: Need close up verifying defect -verify/reasses grade and drainage
