18-4143-00: Hot Springs, AR 2025 SSES

Smoke Observation Summary

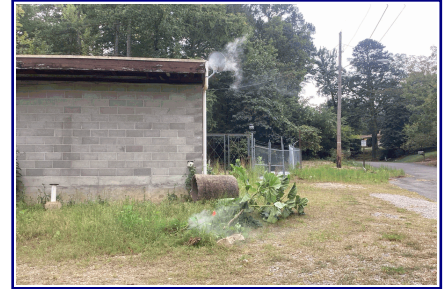
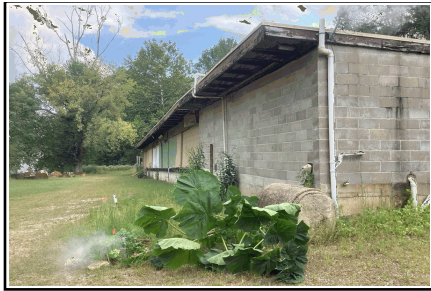
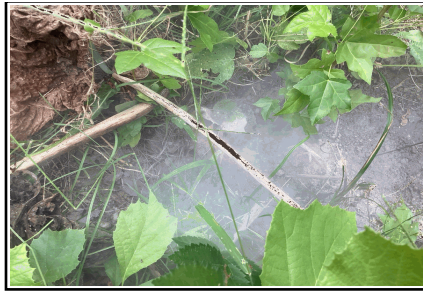
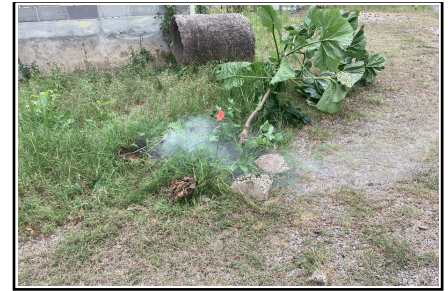
Address: 103 Clarkson St

Cleanout, Defective

Intensity: **High**

Drainage Area (SF): **10**

Surface: **Unpaved**

QC Comments: Need close up that confirms defect

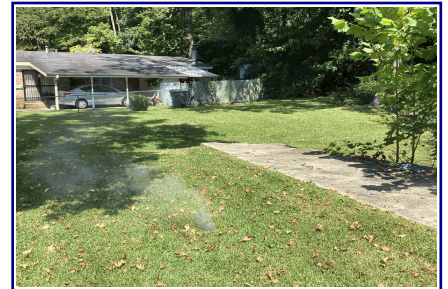
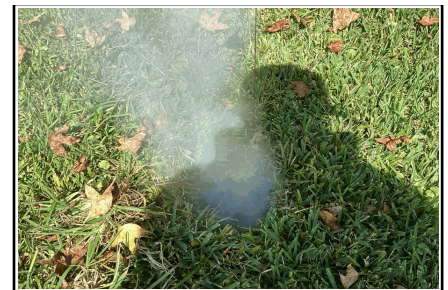
Address: 314 Cedar St

Cleanout, Defective

Intensity: **Low**

Drainage Area (SF): **30**

Surface: **Unpaved**

QC Comments: retake close up without smoke for verification
