30-4076-01: Tulsa Metropolitan Utility Authority (TMUA) TMUA ES 2025-06

Smoke Observation Summary

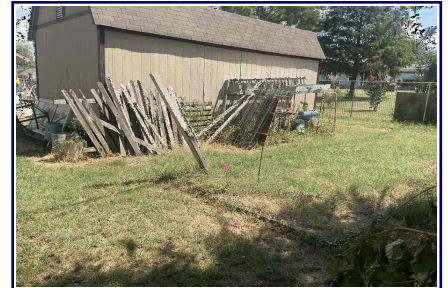
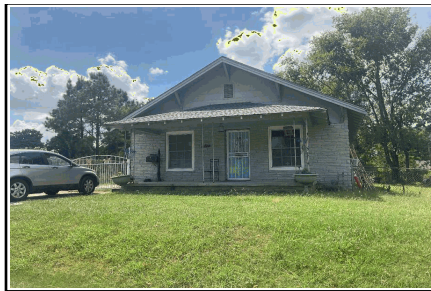
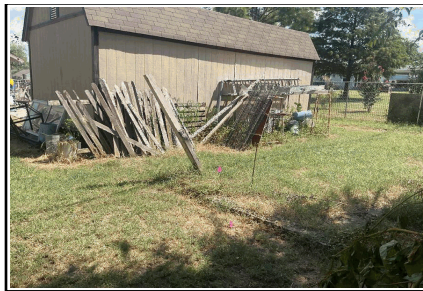
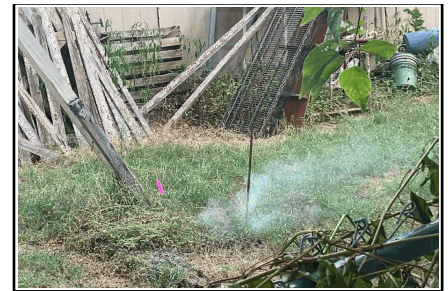
Address: 1132 N Harvard Ave

Cleanout, Defective

Intensity: **Medium**

QC Comments: need close up photo verifying defect

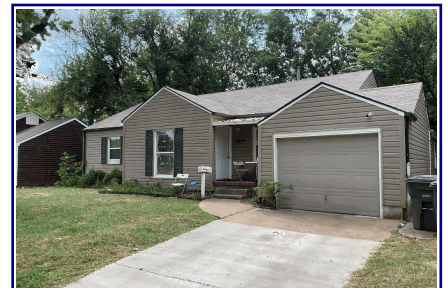
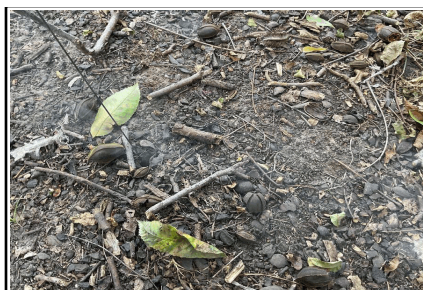
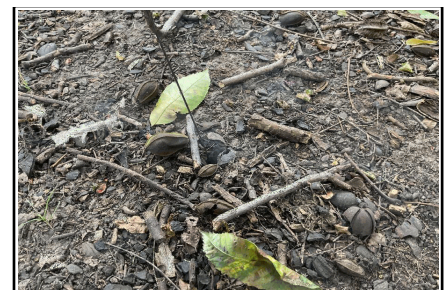
Address: E Oklahoma St E Oklahoma St

Lateral

Intensity: **Low**

QC Comments: retake area photo showing location of defect
