30-4076-01: Tulsa Metropolitan Utility Authority (TMUA) TMUA ES 2025-06

Smoke Observation Summary

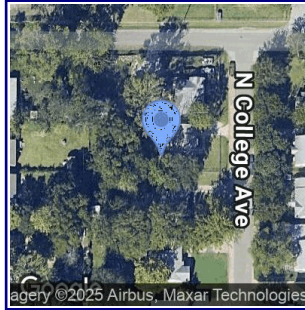
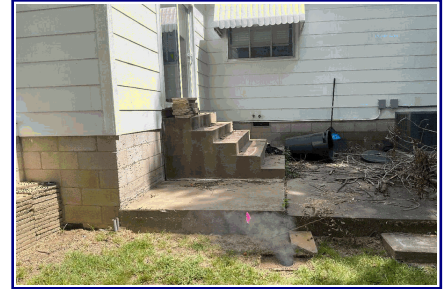
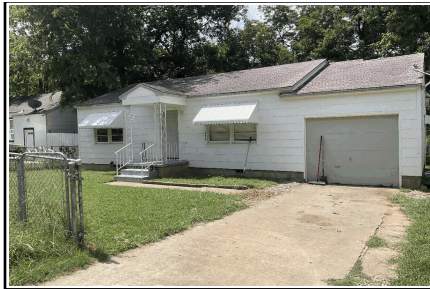
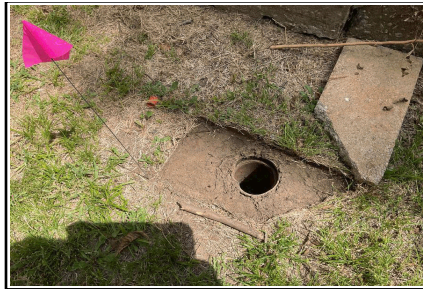
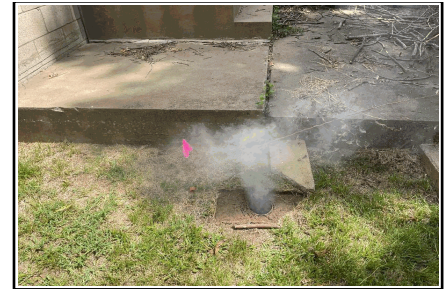
Address: 1046 N College Ave

Cleanout, Missing/Broken Cap

Intensity: **Low**

Drainage Area (SF): **200**

Surface: **Unpaved**

QC Comments: Need area photo that shows drainage/roofline

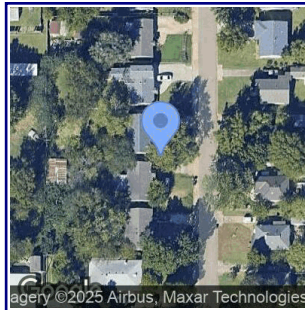
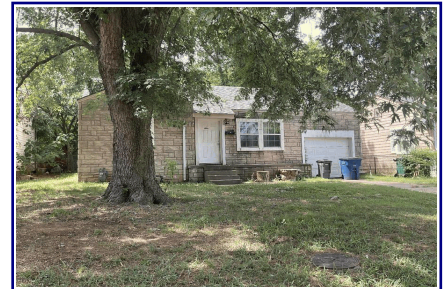
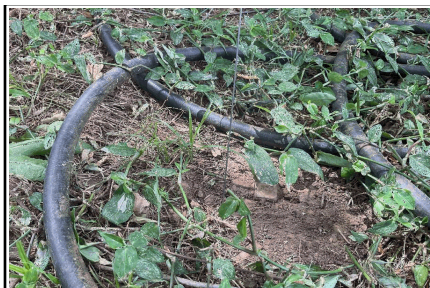
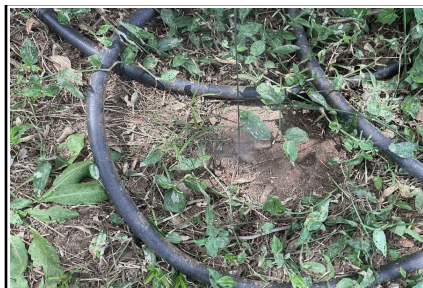
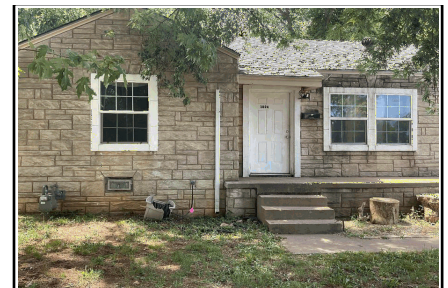
Address: 1024 N Delaware Pl

Cleanout, Missing/Broken Cap

Intensity: **Low**

Drainage Area (SF): **150**

Surface: **Unpaved**

QC Comments: confirm this is a CO - cannot see cleanout in photo, retake showing
