18-4143-00: Hot Springs, AR 2025 SSES

Smoke Observation Summary

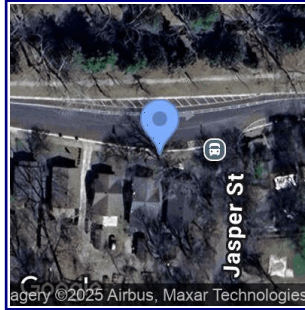
Address: 405 Whittington Ave

Cleanout, Missing/Broken Cap

Intensity: **Medium**

Drainage Area (SF): **25**

Surface: **Paved**

QC Comments: confirm where cleanout defect is - possibly above grade and 0 drainage area - EE

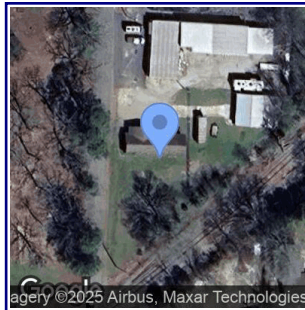
Address: 847 Third St

Cleanout, Missing/Broken Cap

Intensity: **High**

Drainage Area (SF): **10**

Surface: **Unpaved**

QC Comments: Need close up verifying defect -verify/reasses grade and drainage
