18-4143-00: Hot Springs, AR 2025 SSES

Smoke Observation Summary

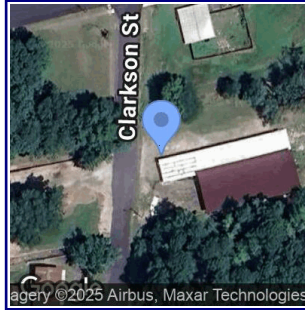
Address: 103 Clarkson St

Cleanout, Defective

Intensity: **High**

QC Comments: Need close up that confirms defect

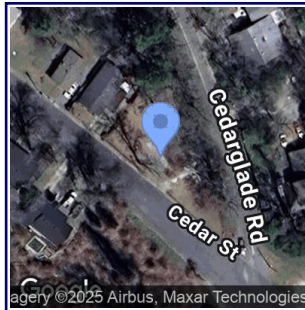
Address: 314 Cedar St

Cleanout, Defective

Intensity: **Low**

QC Comments: retake close up without smoke for verification
