30-4076-01: Tulsa Metropolitan Utility Authority (TMUA) TMUA ES 2025-06

Smoke Observation Summary

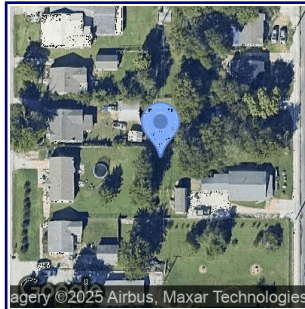
Address: 1132 N Harvard Ave

Cleanout, Defective

Intensity: **Medium**

QC Comments: need close up photo verifying defect

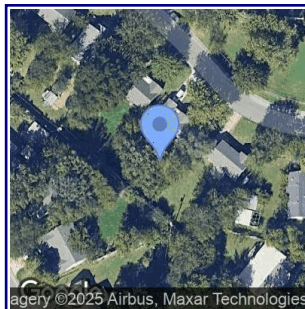
Address: E Oklahoma St E Oklahoma St

Lateral

Intensity: **Low**

QC Comments: retake area photo showing location of defect
