Baltimore Baltimore City 1163		Site Name P8_04_67S_OF	
Inspected By rmxter		Project No. 17-2583-01		Site Code T	
Inspected Date/Time 1/29/2021 10:40 AM					
System Information		Area Location Map		Area View Picture	
Target Pipe Dia. (in) 20.0 Municipality Baltimore City District Jones Falls Assigned Rain Gauge JF12RG Client Manhole # S31MM_013MH Connecting MH I.D. Overflow System Characteristics: Residential - <input checked="" type="checkbox"/> Commercial - <input checked="" type="checkbox"/> Industrial - <input type="checkbox"/> P/S Influence No WWTP Influence No

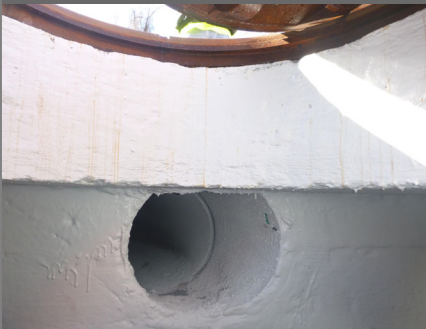
Site Information		Investigation Photo		Installation Photo	
Pipe Height (in) 20.00 Pipe Width (in) 20.00 Pipe Type Lined Pipe Shape Circular O2 20.9 LEL % 0.0 H2S 0.0 CO 0.0

Hydraulic Information		Hydraulic Characteristics No flow. Constructed overflow		Installation Notes	
Flow Depth (in) 0.00 Instant Velocity (fps) 0.00 Surge Evidence (ft) 0.00 Silt Type None Silt Depth (in) 0.00 Needs Cleaning No Backwater No Flow Path Straight Drop Inlet No Hydraulic Rating No Flow		Install Plan Sketch		Install Cross-Section Sketch	
Installation Notes

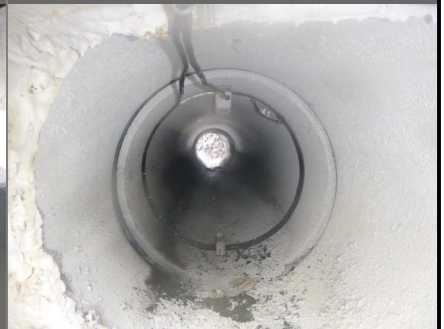
Location in Pipe (ft) 1.0 Location from Manhole Upstream Sensors CS4 and CS5-V2 Antenna Surface Paved Surface Signal Strength 75		Post Installation Notes		Approvals	
Meter Type ADS Triton+ Telemetry Type ADS Installation Date 2/11/2021		Recommended by FSP		Client Approval
