18-4143-00: Hot Springs, AR 2025 SSES

Smoke Observation Summary

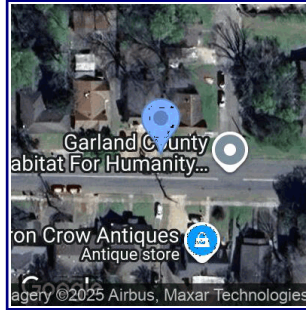
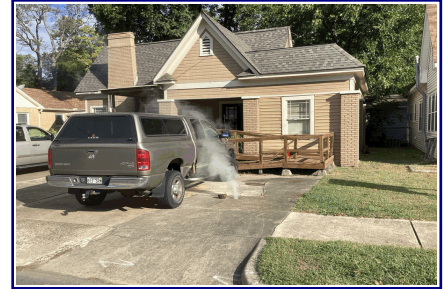
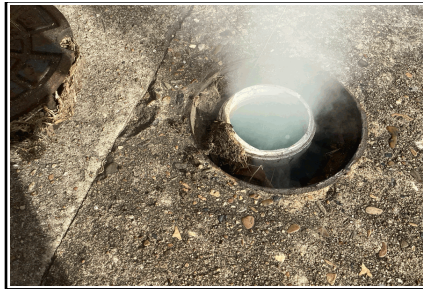
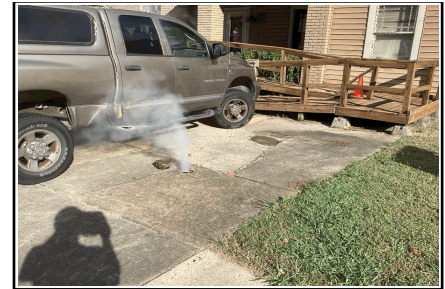
Address: 242 Hobson Ave

Cleanout, Defective

Intensity: **High**

Drainage Area (SF): **10**

Surface: **Paved**

QC Comments: confirm where cleanout defect is - possibly above grade and 0 drainage area - CP

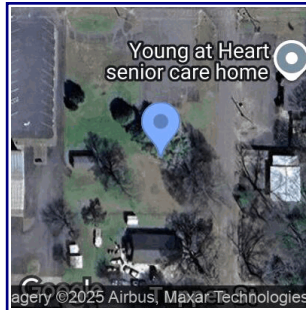
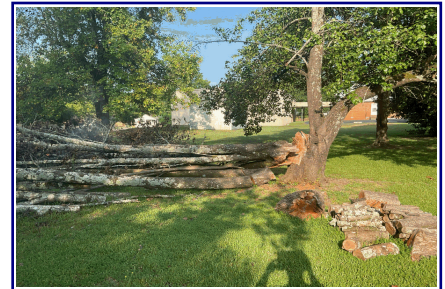
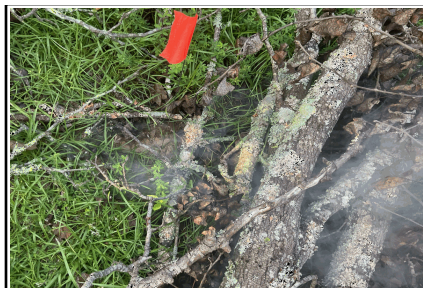
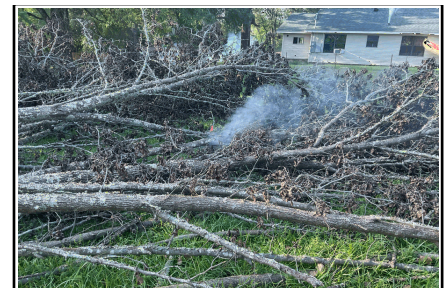
Address: 234 Golf Links Rd

Cleanout, Defective

Intensity: **Medium**

Drainage Area (SF): **25**

Surface: **Unpaved**

QC Comments: Defect not clearly visible, revisit and take additional photo showing defective cleanout
