## 30-4076-01: Tulsa Metropolitan Utility Authority (TMUA) TMUA ES 2025-06

### Smoke Observation Summary

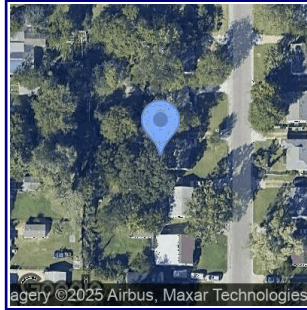
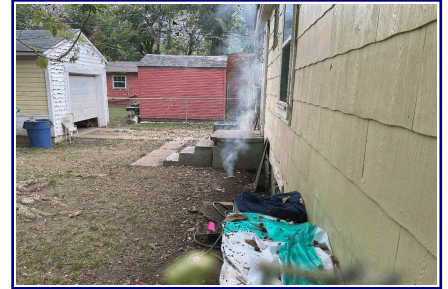
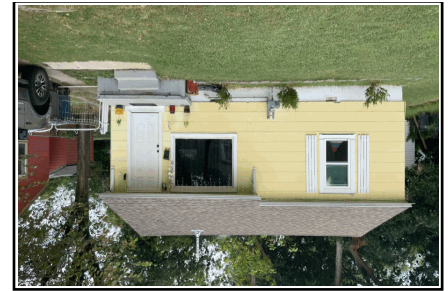
#### Cleanout, Missing/Broken Cap

Address: 1220 N Urbana Ave

Intensity: **High**

Surface: **Unpaved**

Comments: *Dog in yard*

*QC Comments: Unable to access due to dog in yard -  
reattempt close up if possible*

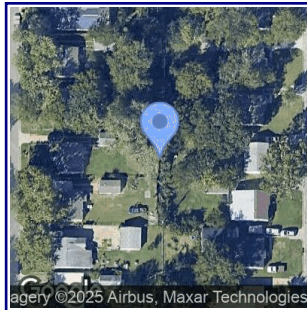
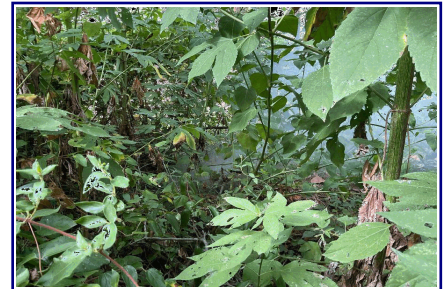
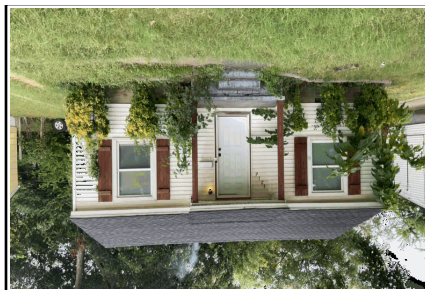
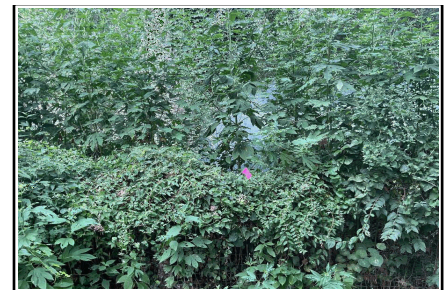
#### Mainline

Address: 1216 N Urbana Ave

Intensity: **High**

Surface: **Unpaved**

Comments: *Possibly a lateral in easement, unable to verify*

*QC Comments: Verify sketch*
